Steam Car Developments Engineering Research and Development Precision Engineering 35 Wood Lane, Beverley East Yorkshire, HU17 8BS UNITED KINGDOM Tel: (44) 1482 863344 Vat No: 599 0585 80

SILENT BLOCS FOR TRACTIONS

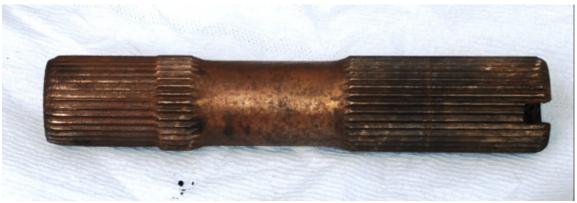
Fig 2 Splined connecting pin for Legere Note how badly worn the splines at the front are and how little engagement there is in the bottom suspension arm at the front.

If you have ever assembled a front cradle you notice how loose the splined connecting pin is as it enters the rear silent bloc yet how tight it is to get it into its final position. That looseness seen in the rear silent bloc is what it is like in the front silent bloc. This is a major design flaw and results in the splines in the front silent bloc and their mating ones on the connecting pin wearing badly - see Fig 2.

As well as the splined connection having to be good the system also relies on the integrity of the rubber connecting the broached tube to the silent bloc housing. It can be seen from the silent bloc shown in Fig 3 that the rubber is well past its 'sell by date'. Remember that the whole suspension geometry relies on the silent bloc assembly being 'tight' and that all the forces created during braking and steering are transferred to the car body via the cradle, silent blocs, bottom suspension arm and the splined connecting pin. When MOTs were mandatory it seemed that most MOT test stations took the approach that it was an old car, not driven very far or fast and that they would be alright. Any similar play in a modern car and it would be failed! And now you do not even have to have an MOT! The badly worn splines/decayed rubbering shown in Figs 2 & 3 came from a car with a current MOT!

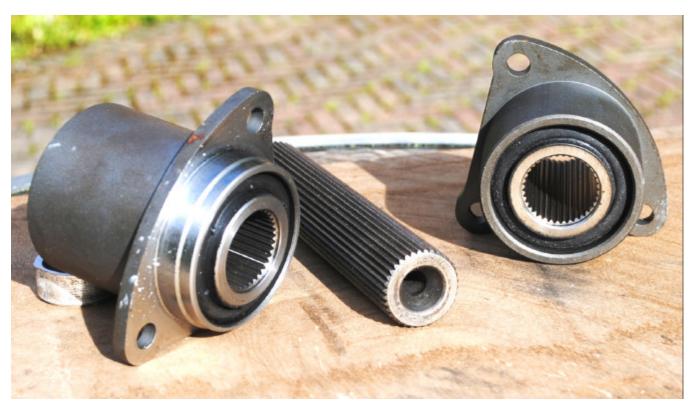
Fig 4 New silent blocs set. The silent bloc housings are machined from a solid billet of steel, the broached tube is concentric with the silent bloc housing and the connecting pin is splined over its full length

There are new silent bloc systems that eliminate the problems of the original ones but being made from all new parts are expensive - see Fig 4. There is no exchange and they are compatible with the Normale/Legere cradle and bottom suspension arms.

- a heavy press is not required to assemble them it can be done by a single person with a 7lb copper hammer
- they dispense with packing shims yet give the correct alignment and 'nip' to the bottom suspension arm
- gives full and even contact between the splined connecting pin, the broached tube in the silent bloc and bottom suspension arm

• the splined tube is concentric with the housing and hence no additional stresses are induced during assembly

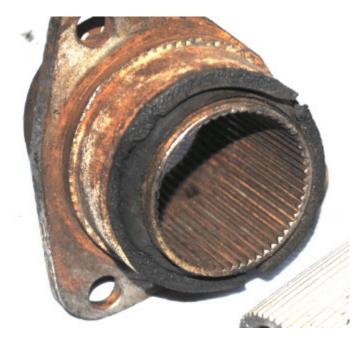
Again all the original silent bloc systems for the Big 6 & 15/6 are well over fifty years old and you can see the problems currently being experienced with decaying rubber in the silent blocs, Fig 6, and distortion in the splined connecting tube, Fig 7.

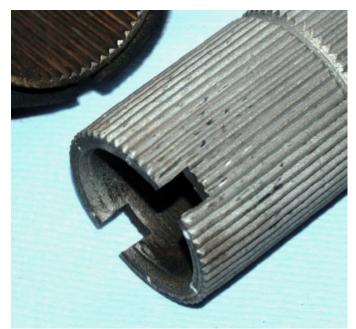
Fig 7 You can just see the distortion to the splined tube at the slot this causes damage to the broached tube in the silent bloc during both assembly and dismantling.

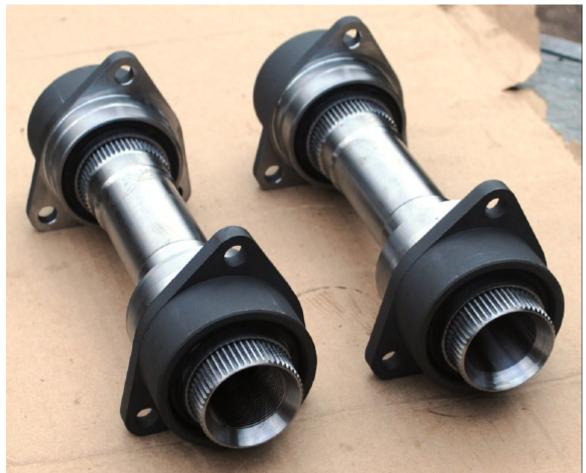
Fig 8 New silent blocs with their splined connecting pins

Fig 8 shows these newly manufactured silent blocs as supplied and Fig 9 as fitted to a cradle.

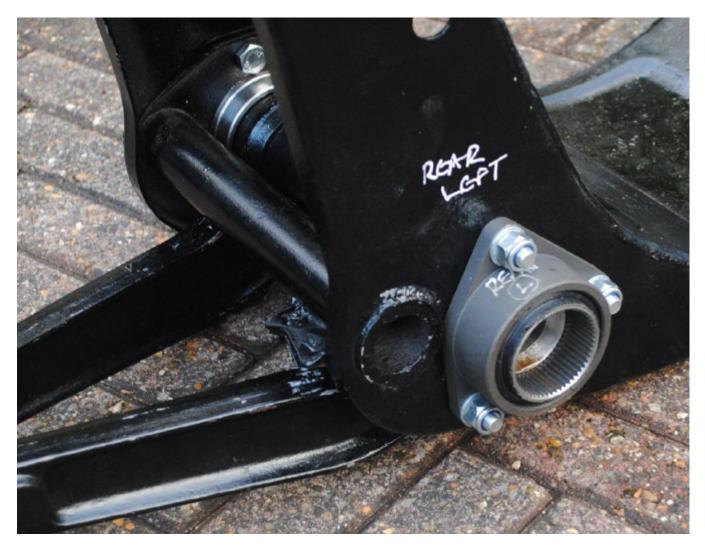
Fig 9 Silent blocs fitted to cradle
